NBSIR 75-703

A Failure Hypothesis for Masonry Shearwalls

Felix Y. Yokel and S. George Fattal

Final Report

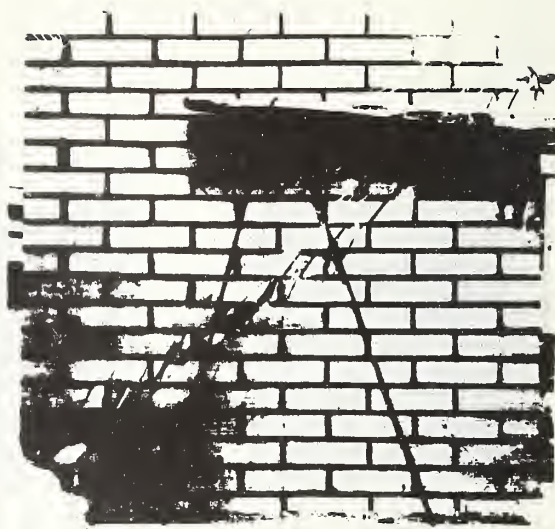
BH 3

BH 7

SH 5

FIGURE 6 FAILURE MODES OF SPECIMENS TYPE BH AND SH

Figure 11 shows a plot of test series BH. Figure 6 shows the failure modes of specimens BH3 and BH7 which appear to be splitting that includes the region near the center of the panel. The plot in figure 11 shows reasonable agreement with curve 2 for the strength-envelope hypothesis.

Figure 12 shows a plot of SH test series. The failure mode of specimen SH5 is shown in figure 6.

Specimen SH8 falls below this line. The correlation between the tests suggest that the failure may have been caused, or triggered, by joint separation. Close examination of specimen SH5 in figure 6 reveals partial joint separation.
